SAMPLE Pre Purchase Report of Marine Survey

Of the GEMINI 105 Sailing Vessel

DATE: 24 June 2002

File Number	20020624-1
Survey Prepared for:	CLIENT
Name of Vessel:	“YOUR VESSEL”
Type of Survey:	Pre Purchase Condition and Value Survey
** Overall Vessel Rating:	“BUC® Condition” Ready for sale requiring no additional work and normally equipped for her size.

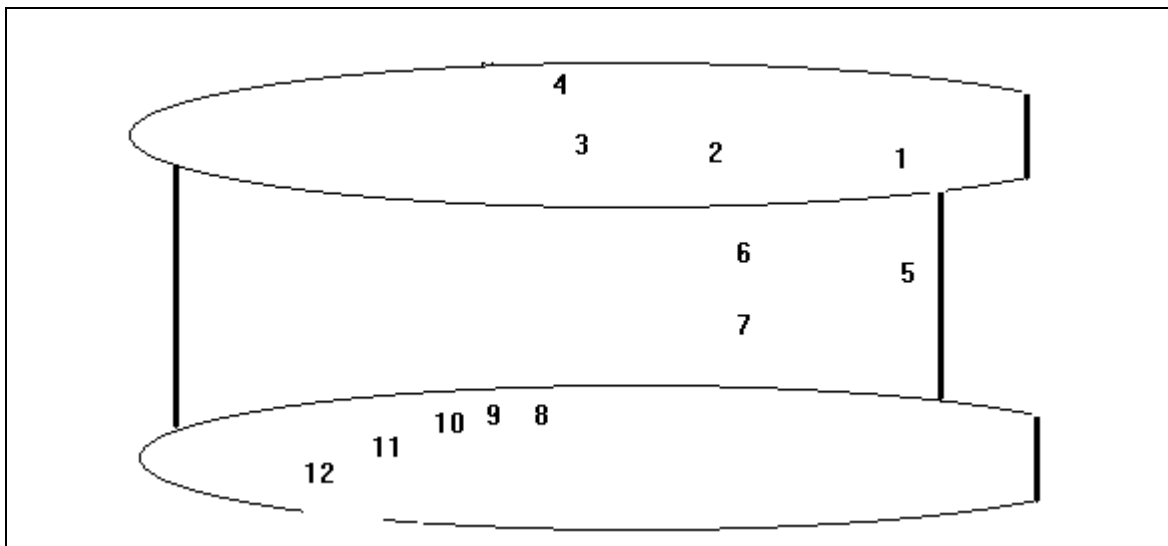
Through-Hull Fittings

LOCATION	USE	MATERIAL	TYPE	COMMENTS
1	Engine Raw Water Intake	Metal	Seacock	GOOD CONDITON
2	Depth Transducer	Plastic	Fixed	GOOD CONDITION
3	Speed Paddlewheel	Plastic	Bayonet	GOOD CONDITION
4	Galley sink	Plastic	Open flange	GOOD CONDITION
5	Engine Exhaust	Metal	Open Flange	GOOD CONDITON
6,7	Cockpit drains	Plastic	Open Drain	GOOD CONDITION

8	Holding tank vent	Plastic	Open Drain	GOOD CONDITION
9	Shower sump discharge	Plastic	Open Drain	GOOD CONDITION
10	Head sink discharge	Plastic	Open Drain	GOOD CONDITON
11	Head raw water intake	Metal	Seacock	GOOD CONDITON
12	Head raw water discharge	Metal	Seacock	GOOD CONDITON

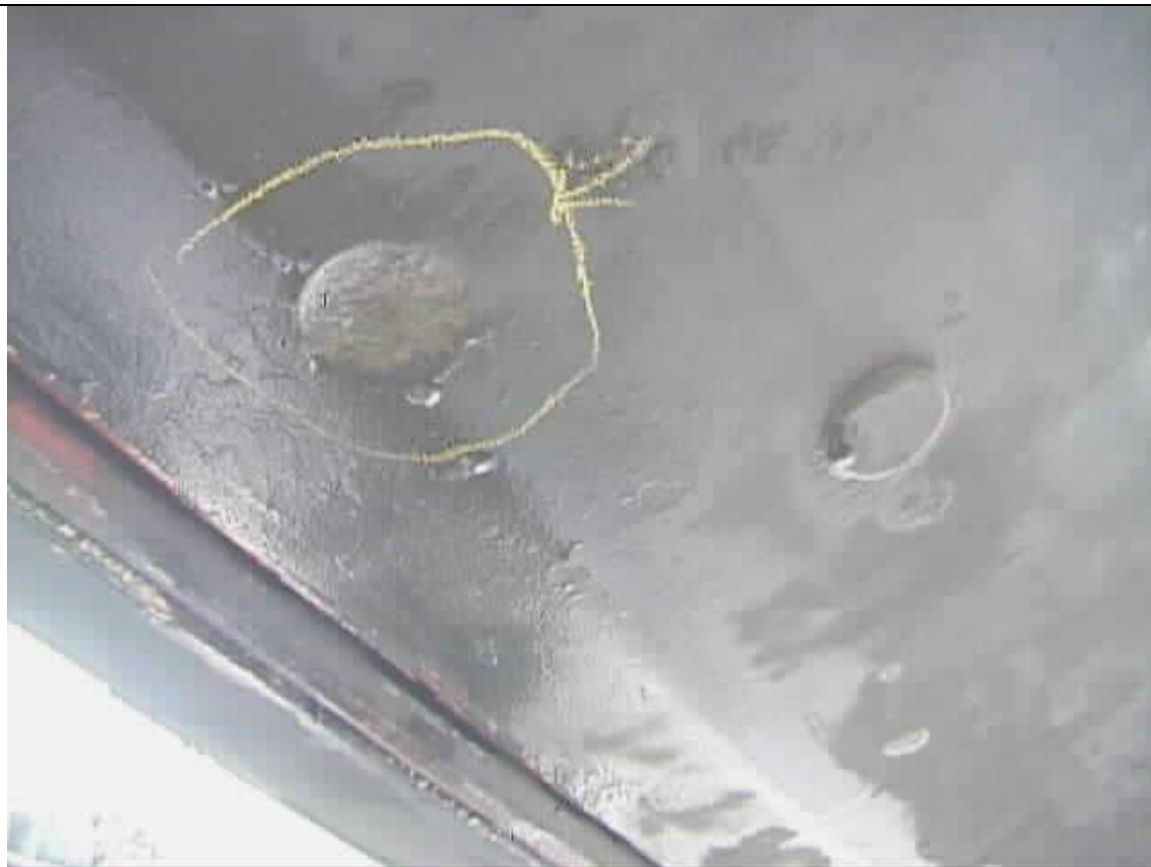
Starboard hull near transducer. The circled area shows where the hull was ground out (3 inches in diameter) and not faired back to the shape of the hull.

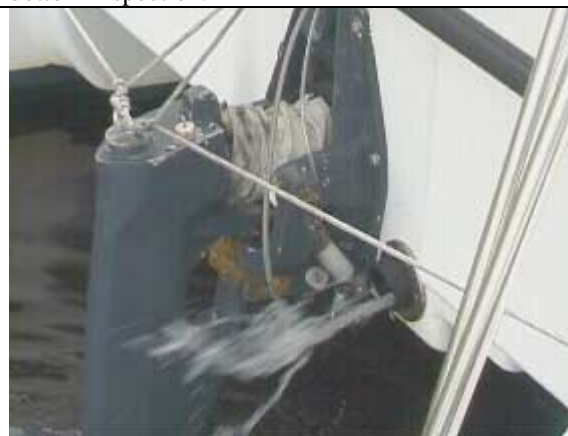
View of the outdrive and the engine exhaust port (lower right hand portion of photograph). Water flow was adequate and engine did not overheat during seatrial stress test.

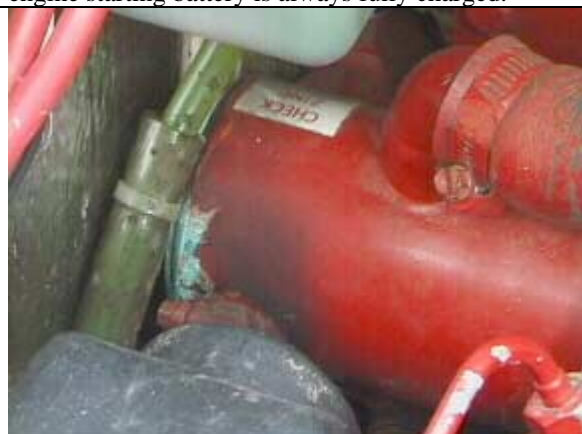
Item	Description
Westerbeke Engine	*B3 GOOD CONDITION there were no leaks, however I suggest that you examine the pencil zinc on the heat exchanger.

View of turquoise corrosion on heat exchanger. Check the condition of the sacrificial pencil zinc.

Reference: B3	*B3 GOOD CONDITION there were no leaks, however I suggest that you examine the pencil zinc on the heat exchanger.
Recommendation	Turquoise corrosion on the heat exchanger suggests that the pencil zinc in the heat exchanger is not working effectively. Have the zinc checked and renewed if necessary.
Reference: B4	*B4 GOOD CONDITION The terminals were clean. However the rear of the panel is not shielded and does not comply with ABYC recommendations.
Recommendation	Install a shield on the back of the 110 vAC panel(s) to prevent accidental electrocution when working on the 12vDC and 110vAC panels.
Reference: B5	*B5 GOOD CONDITION Note that the unit is vented in the cabin and the odor from the holding tank is very noticeable. The tank is hidden under the forward bulkhead in the left float.
Recommendation	Investigate venting the holding tank outside of the boat.
Reference: B6	*B6 UNIT POWERED UP and held a steady course during the sea trial Note: the remote control is not working.

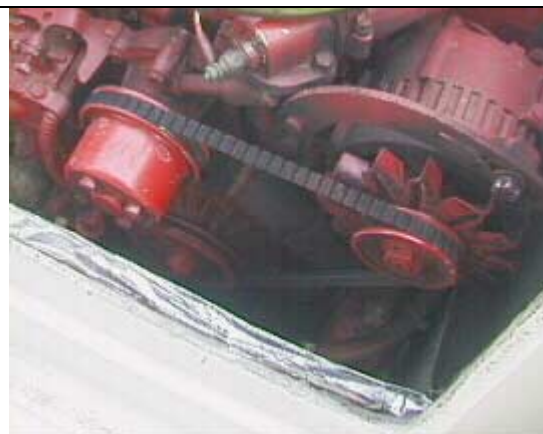
Black dust from the fan belt attached to the alternator. Check belt alignment and renew belt as needed.

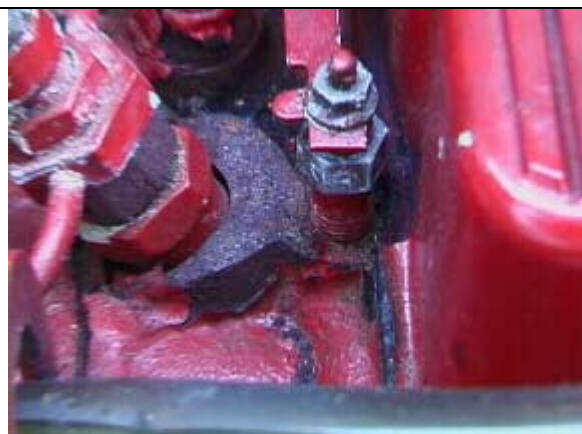
Rust developing on surface of engine and around injector ports. Clean, repaint, and treat with anti corrosion compound.

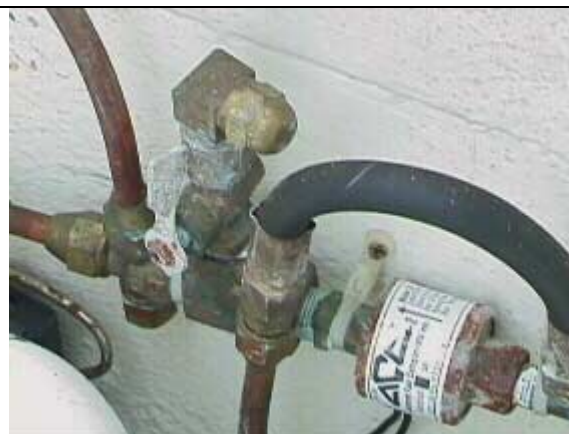
View of propane solenoid. Note capped fitting which led to the propane refrigerator. Read comment section on Propane system.

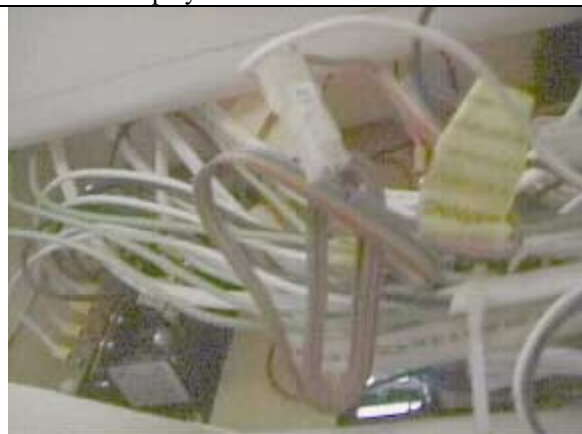
Item	Description
125 VAC breaker box is a completely separate unit from the 12VDC breaker box.	*B4 GOOD CONDITION The terminals were clean. However the rear of the panel is not shielded and does not comply with ABYC recommendations.
30 amp 125 VAC shore power cord	GOOD CONDITION both power cord and onboard plug in socket were free of scorch and burn marks
1000 watt Heart inverter with 50 Amp Battery Charger	APPEARED TO BE IN GOOD CONDITION Battery charging indicator light was on.
5 each 110volt AC outlet boxes.	GOOD CONDITION Outlet boxes in the cabin were tested and found to be properly grounded.

View of access to 12vDC and 110vAC electrical panels. Note that the rear of the 110vAC is not shielded.
