Report of Marine Survey  
Of a 2007 SEARAY 44DB POWER VESSEL

"LOVIN LIFE"  
Conducted by:

John N. Allinson, II  
SAMS® ACCREDITED MARINE SURVEYOR  
Certified Infrared Thermographer

PREPARED FOR: CLIENT  
DATE: 11 December 2009

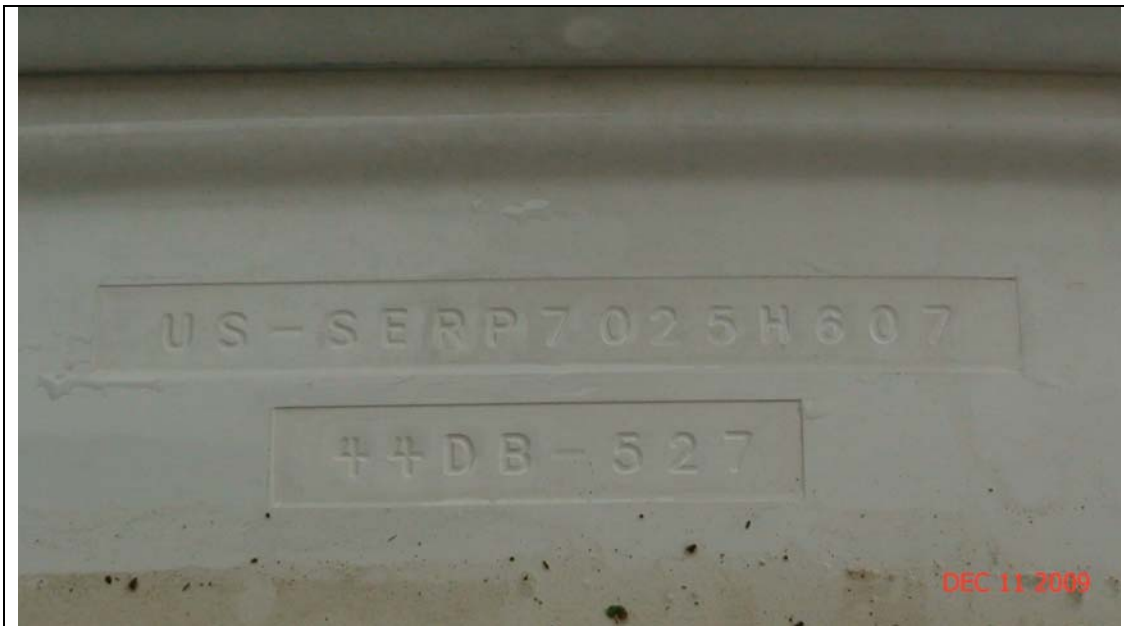
Digital photograph of Hull Identification Number.

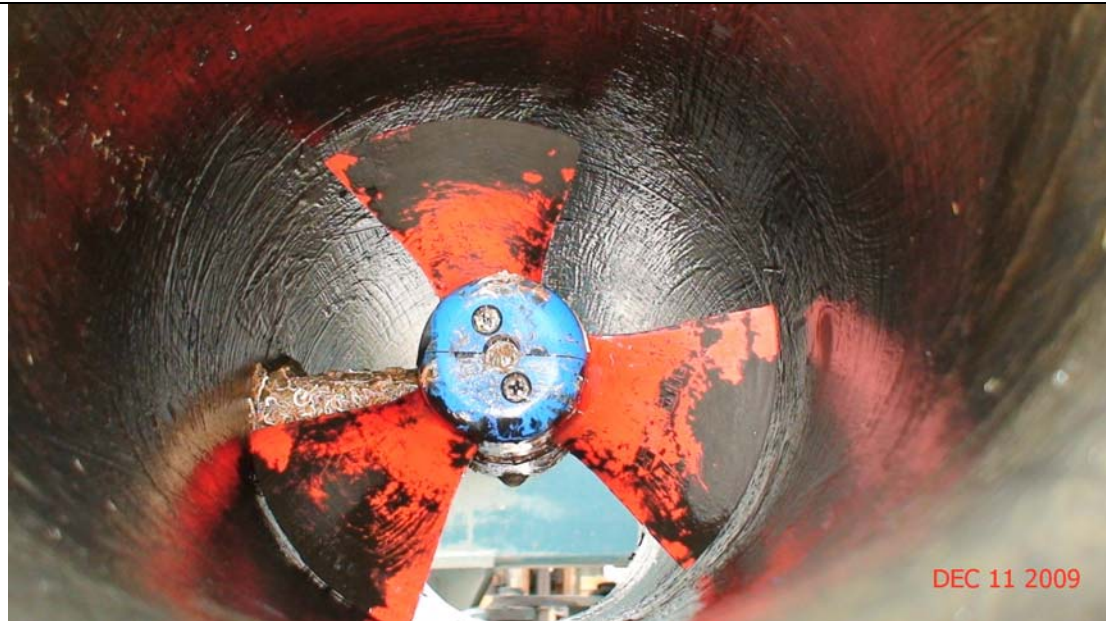
Bow thruster assembly. Monitor condition of any metal parts here and protect as necessary from galvanic corrosion.

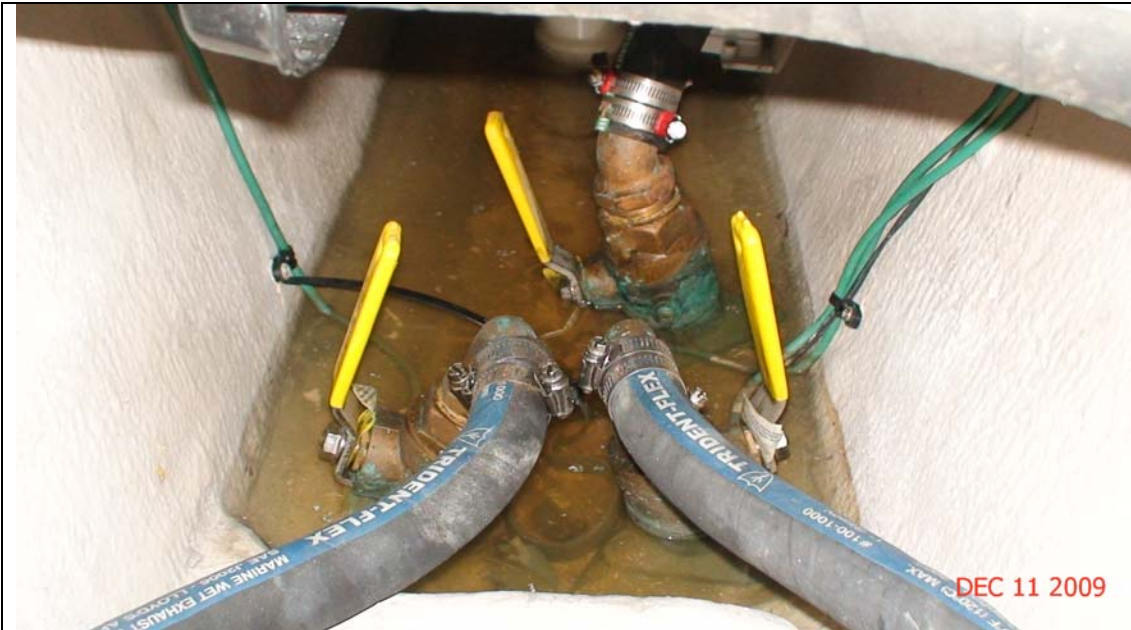
Aft seacock is for emptying the holding tank. It should be secured in the closed position. Bilge in this area should be clean and dry. Seacocks should be treated with anticorrosion products.

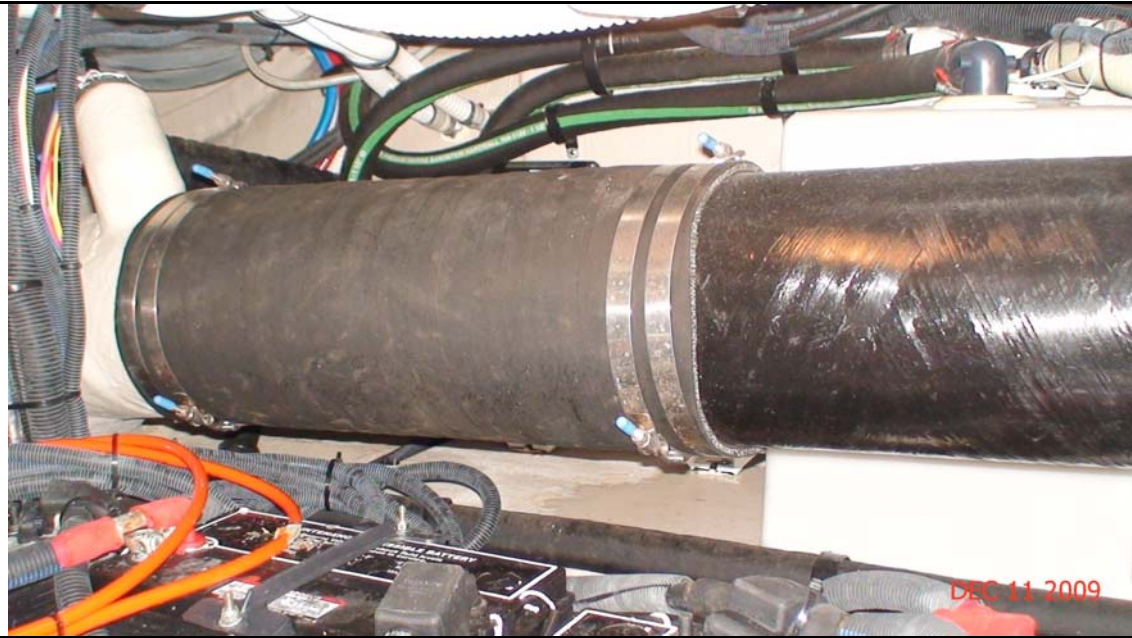
Wet exhaust system for CUMMINS engines in good condition.

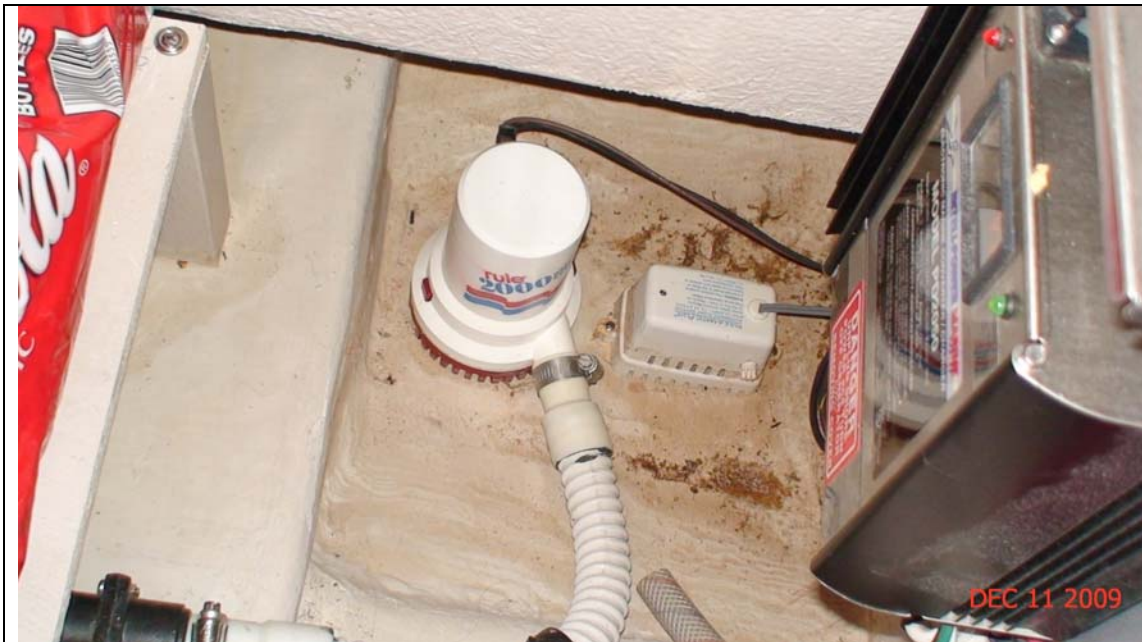
Forward bilge pump. Bilge was dry but had some debris that needs to be cleaned.

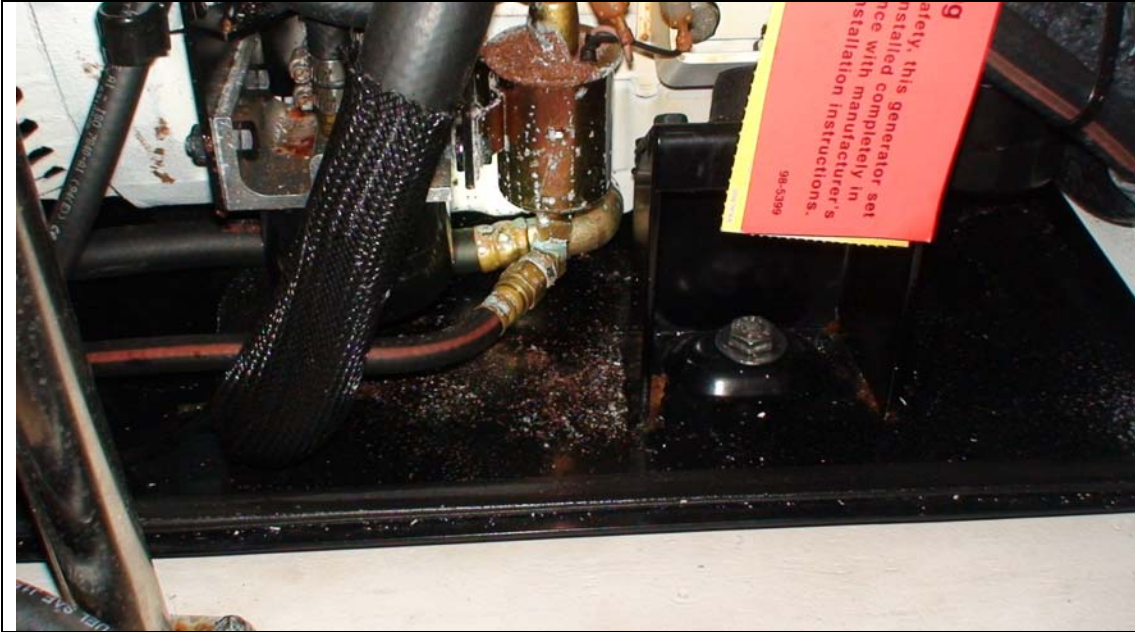
Slight corrosion in ONAN generator housing. Preventative maintenance needed.

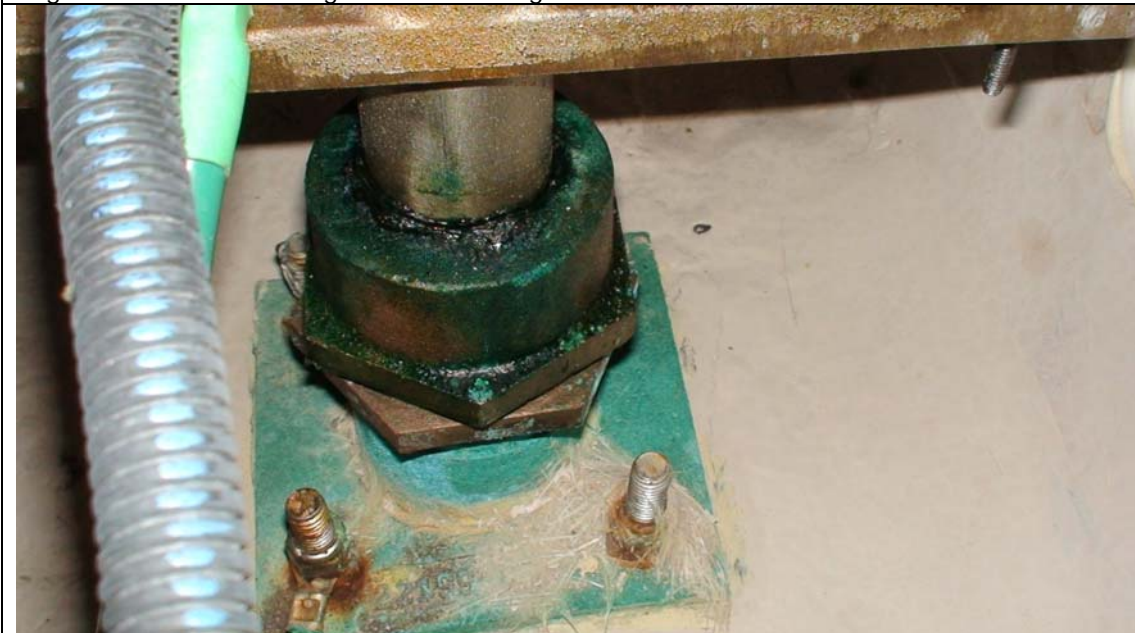
Verdigris around shaft log for rudder posts. Preventative maintenance needed

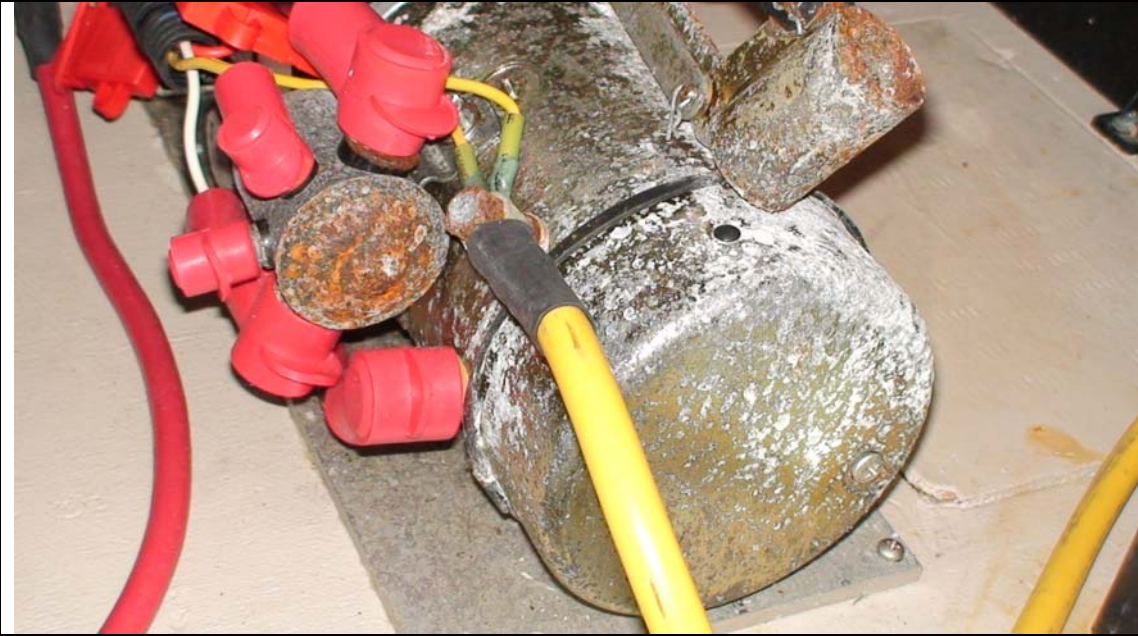
Surface corrosion on hydraulic dinghy lift. Preventative maintenance needed.

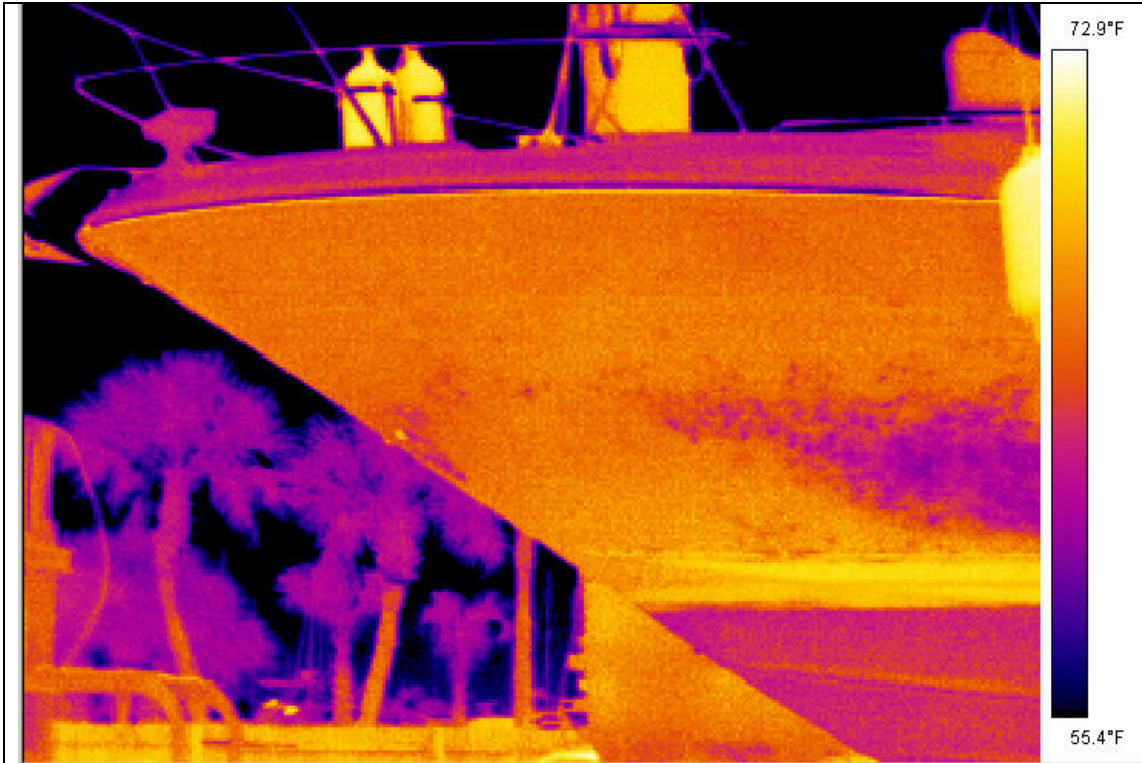
Port side bow.

The following images are preliminary scans just after the boat was hauled for bottom inspection. Surface water spray is evident on the hull, no signs of water intrusion and delamination seen.
