Prepurchase Report of Marine Survey  
Of a 30 foot 1989 Catalina C30 Tall Rig Sailing Vessel

"BLACKSHEEP II"

DATE: 5 December 2009

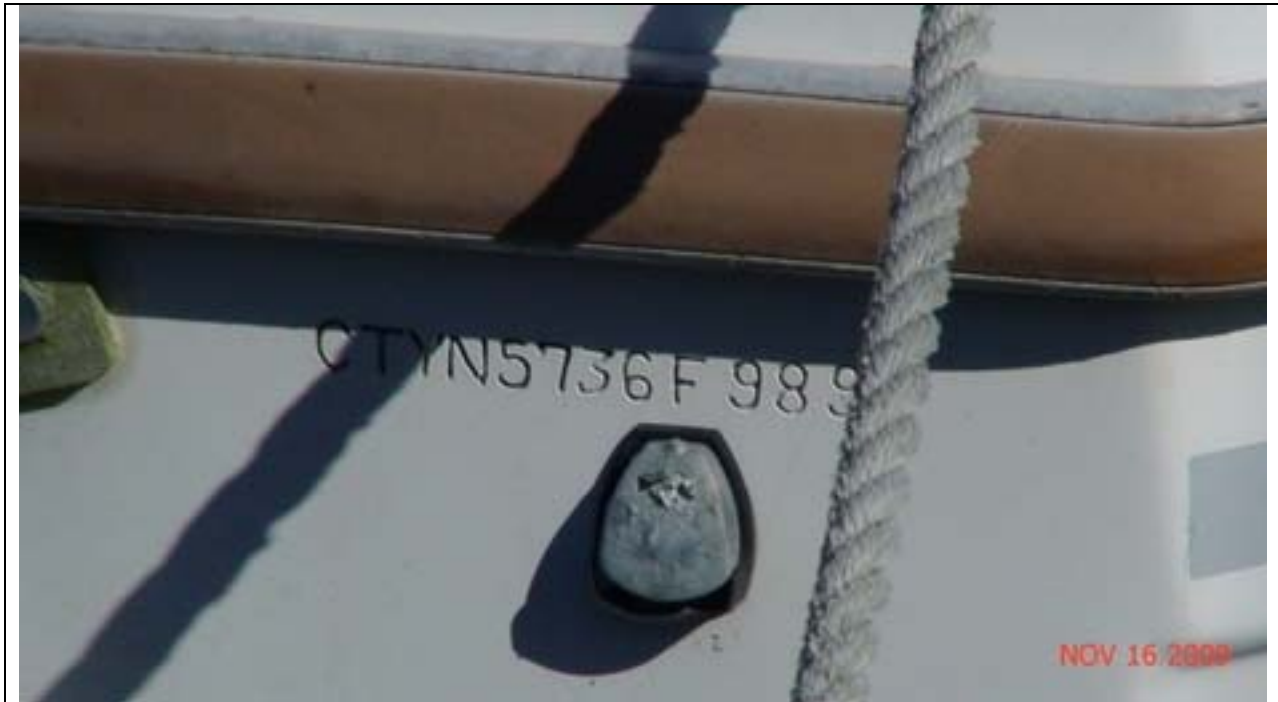
Digital Photograph of HIN  
Note that this was engraved into the hull rather than imprinted from the mold.

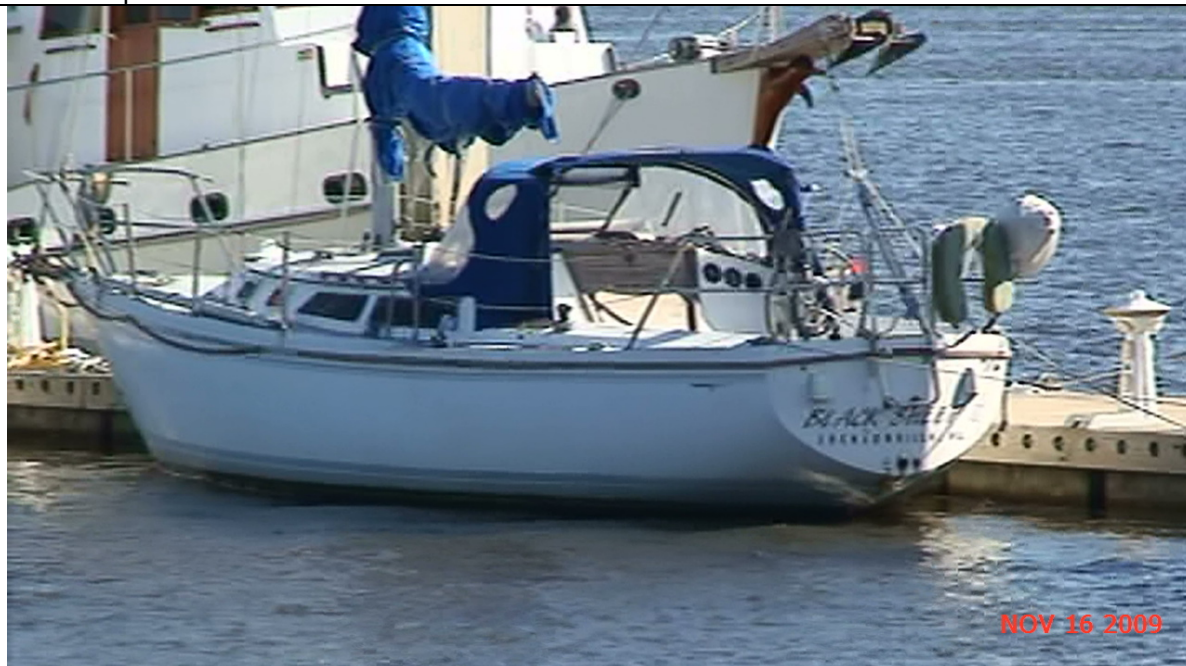
Item	Description
Style is overlapping shoebox and secured with mechanical fasteners.	<b>*B5 SERVICEABLE</b> Visible areas of the hull to deck joint show no visible signs of damage, fatigue, or unusual stress and loading points. Rub rail on the other hand is loosing its vinyl insert on the port side.

Vessel is tied starboard side to the floating dock. Evident in the photograph is the insert on the rub rail which is coming apart from the bow extending back to the lower aft shroud.

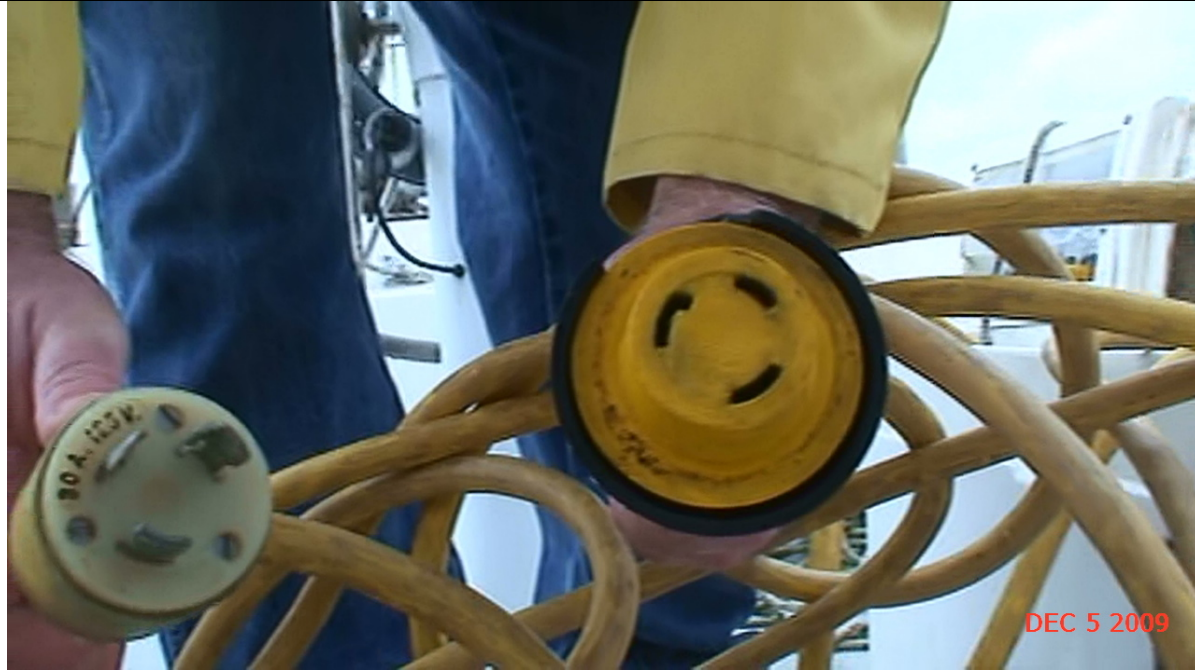
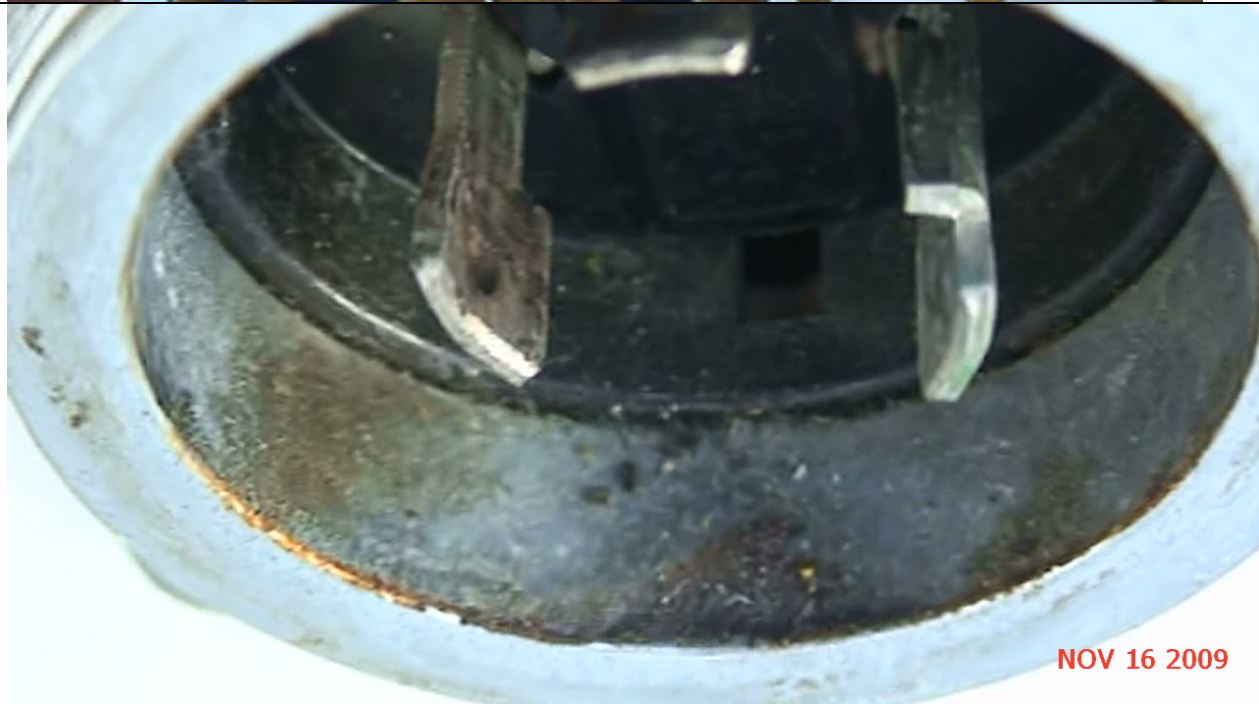
Item	Description
30 amp 120vAC shore power inlet located in cockpit, power cable stored in port side lazarette in the cockpit	<b>SERVICEABLE CONDITION</b> pins on shore power inlet were clean and free of burn or scorch marks. Power cord and terminal plugs serviceable with no visual signs of burn or scorch marks.
120vAC outlets	<b>*B13 SERVICEABLE</b> outlets were grounded properly and GFCI protected, however GFCI did not trip when tested.

Most electrical fires on boats involve shore power cords and inlets. Make sure that you routinely inspect these and renew should burn or scorch marks develop.

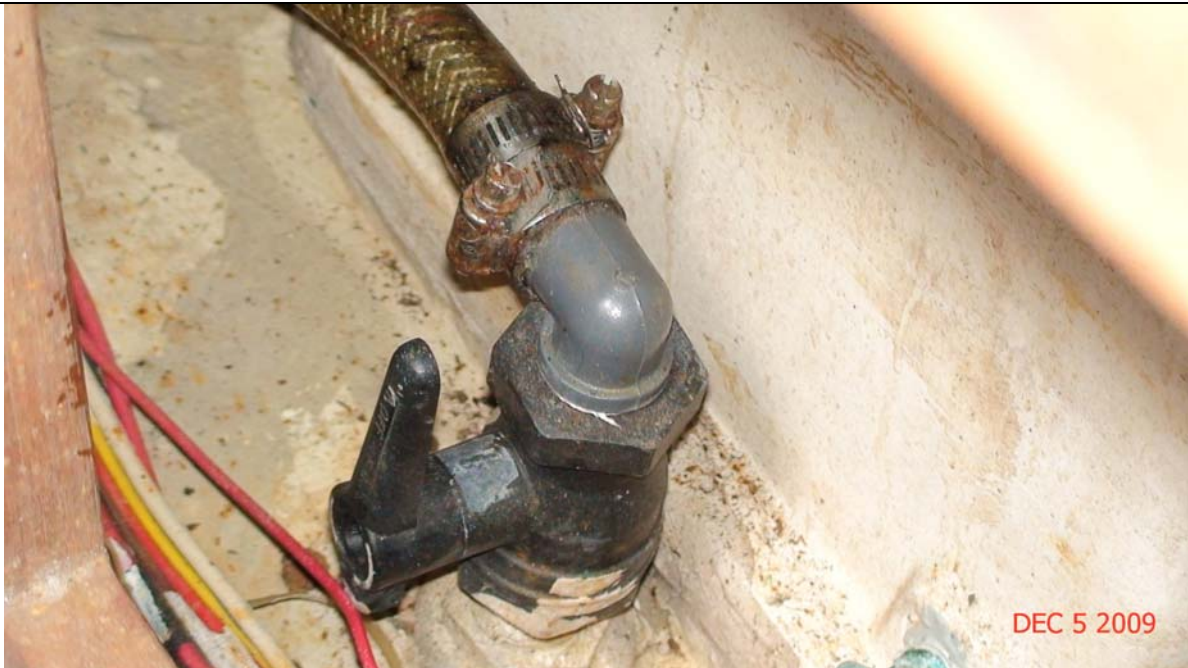
Item	Description
Through hulls are MARELON fiberglass reinforced plastic and need no bonding wires.	<b>SERVICEABLE</b> hoses are double clamped and are in good condition.

Renew hose clamps when they show signs of corrosion. Treat hose clamps to prevent corrosion. Periodically exercise seacocks. Renew hoses when they show signs of wear. Keep the bilge area clean and free of debris.

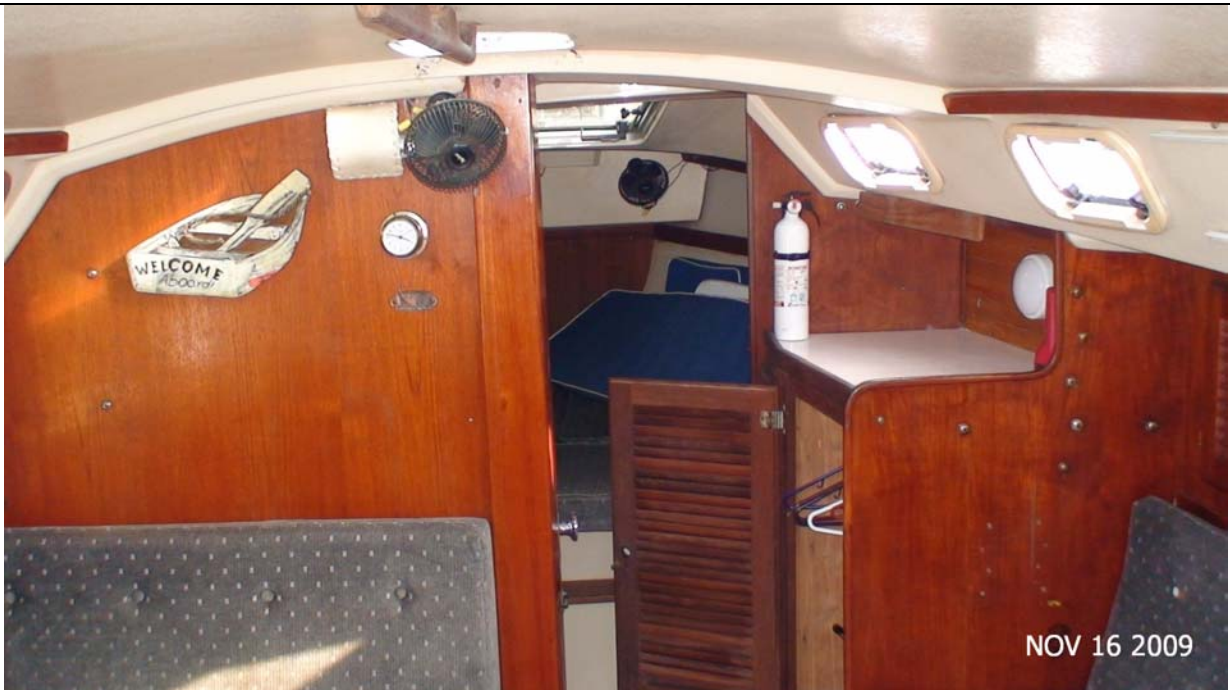
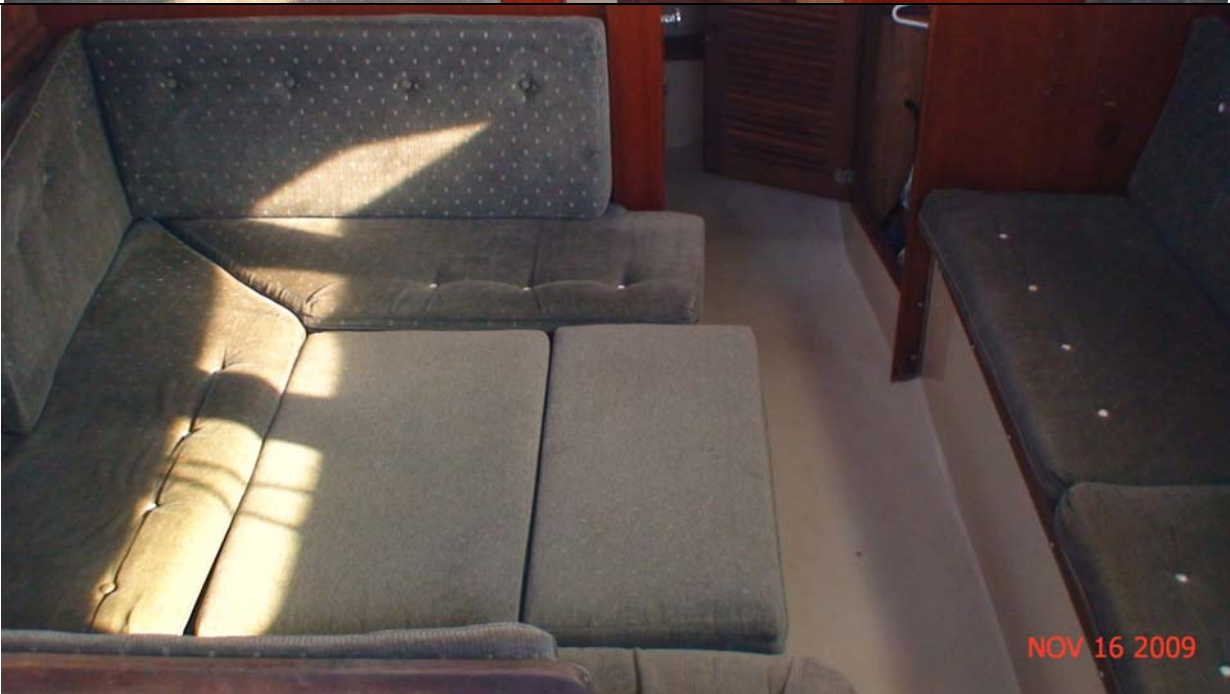
Example of general housekeeping on vessel during inspection

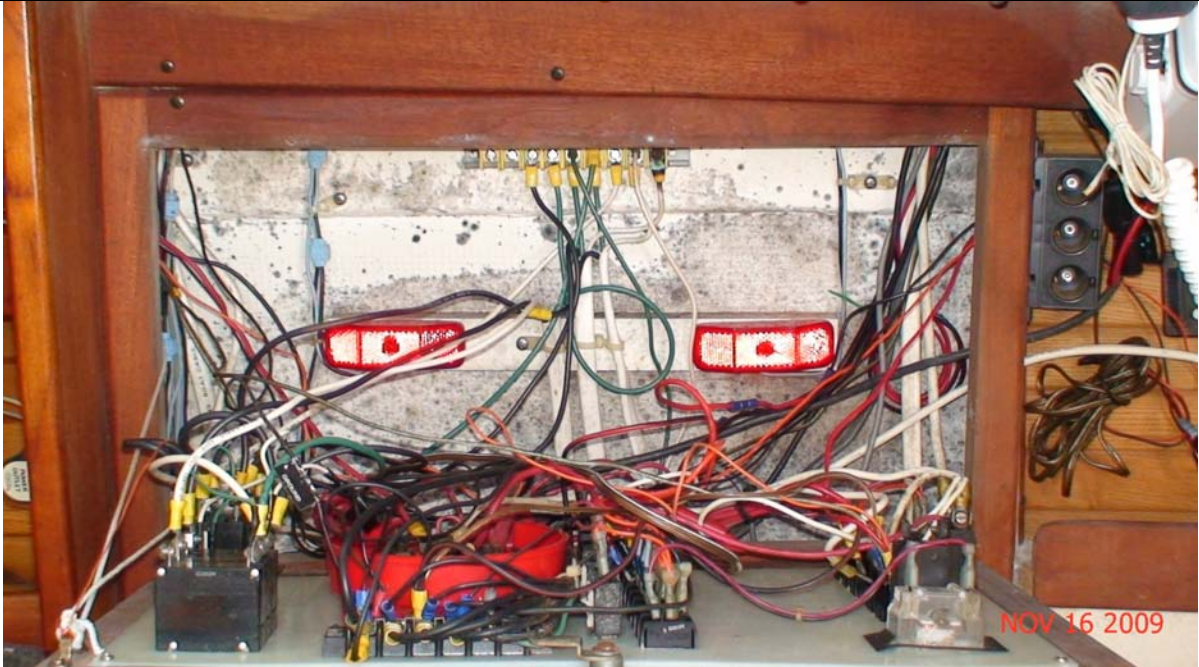
Combination 120vAC and 12vDC electrical panel. 120vAC portion of the panel needs to have the terminals shielded from accidental contact.

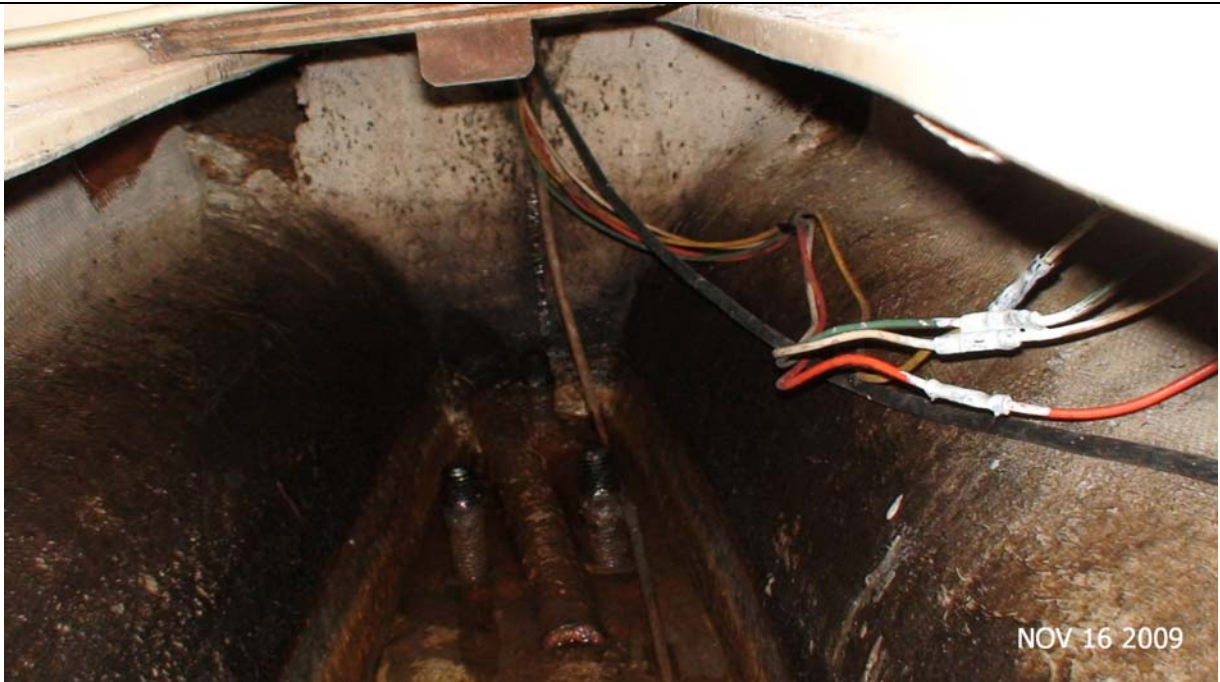
Keel bolts need to be cleaned and treated, bilge needs to be cleaned, 12vDC wires need to be supported.
